**RE: Permit Application for Water/Wetland Projects
United States Steel Corporation, Minnesota Ore Operations – Minntac
Western Tailings Basin Seepage Collection System**

Minnesota Local/State/Federal Application Form for Water/Wetland Projects

**U.S. Steel Corporation - Minnesota Ore Operations
Minntac Western Seepage Collection Project**

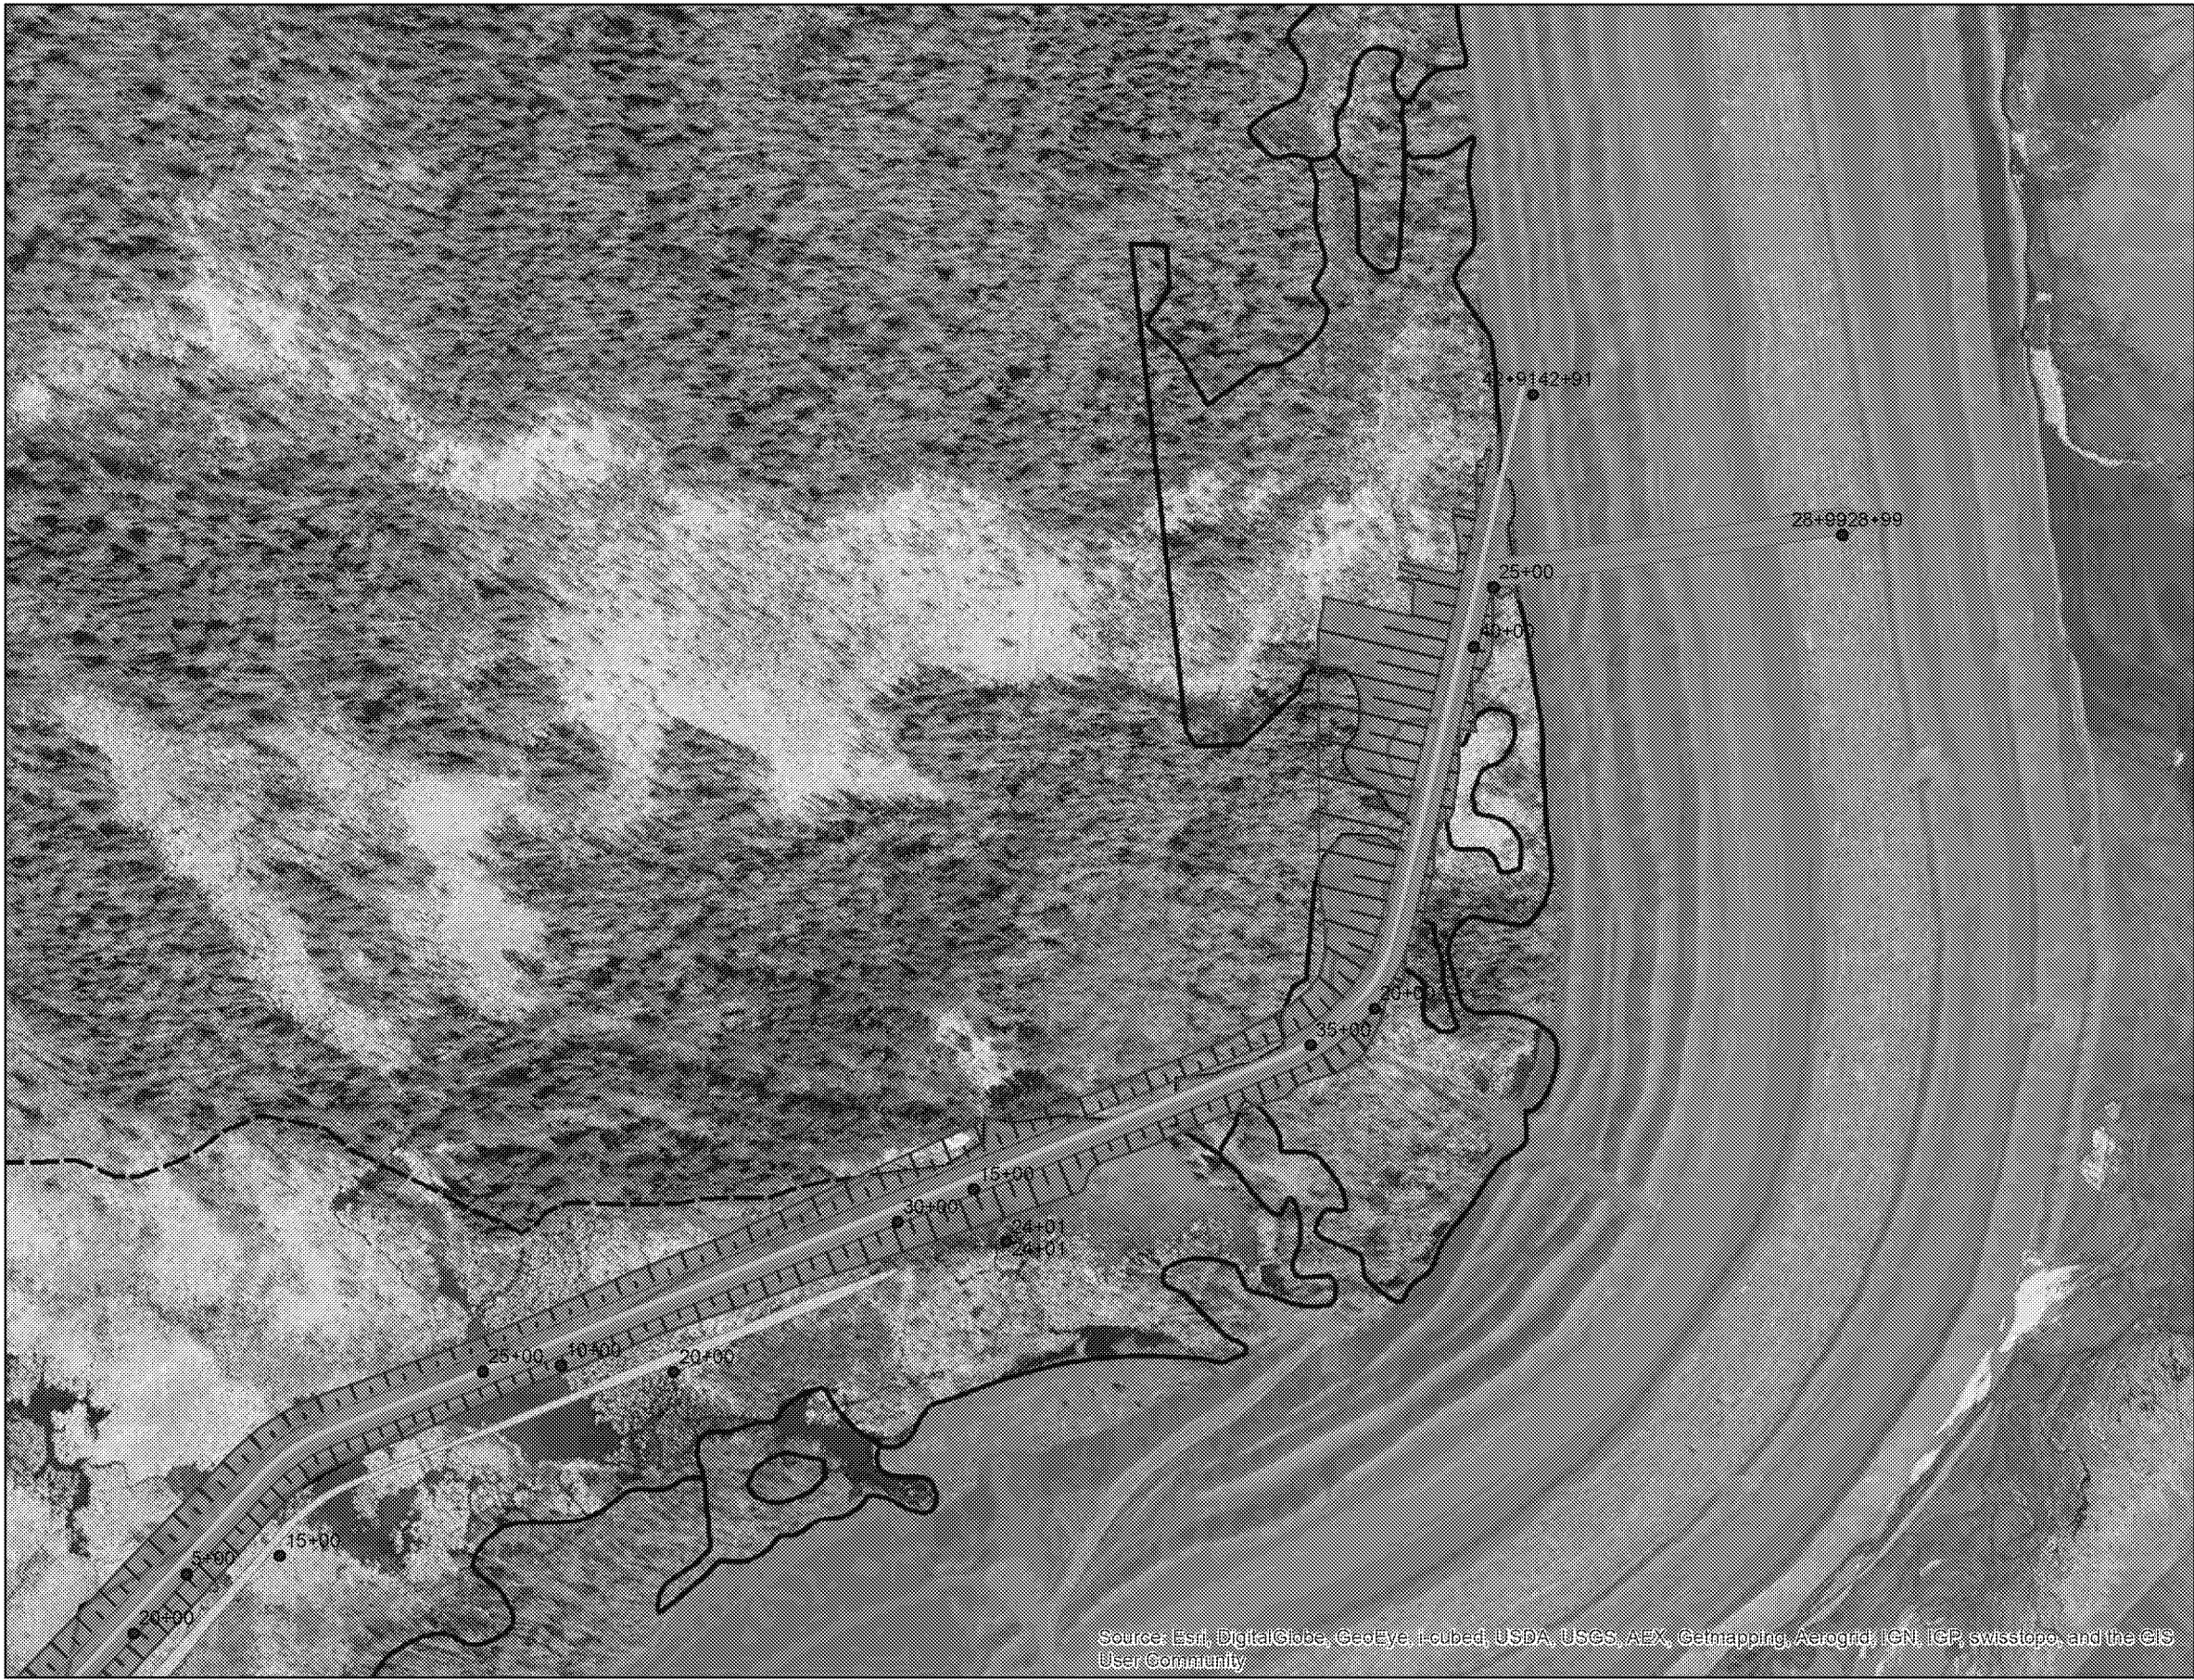
Figure 6
Wetland Impacts

- Legend**
- Road Centerline
 - Force Main
 - Seep Collection Direct Impacts**
 - Road
 - Seep Collection Hydrologic Impacts**
 - French Drain
 - Wetland Boundary 2012
 - Estimated Wetland Boundary 2014

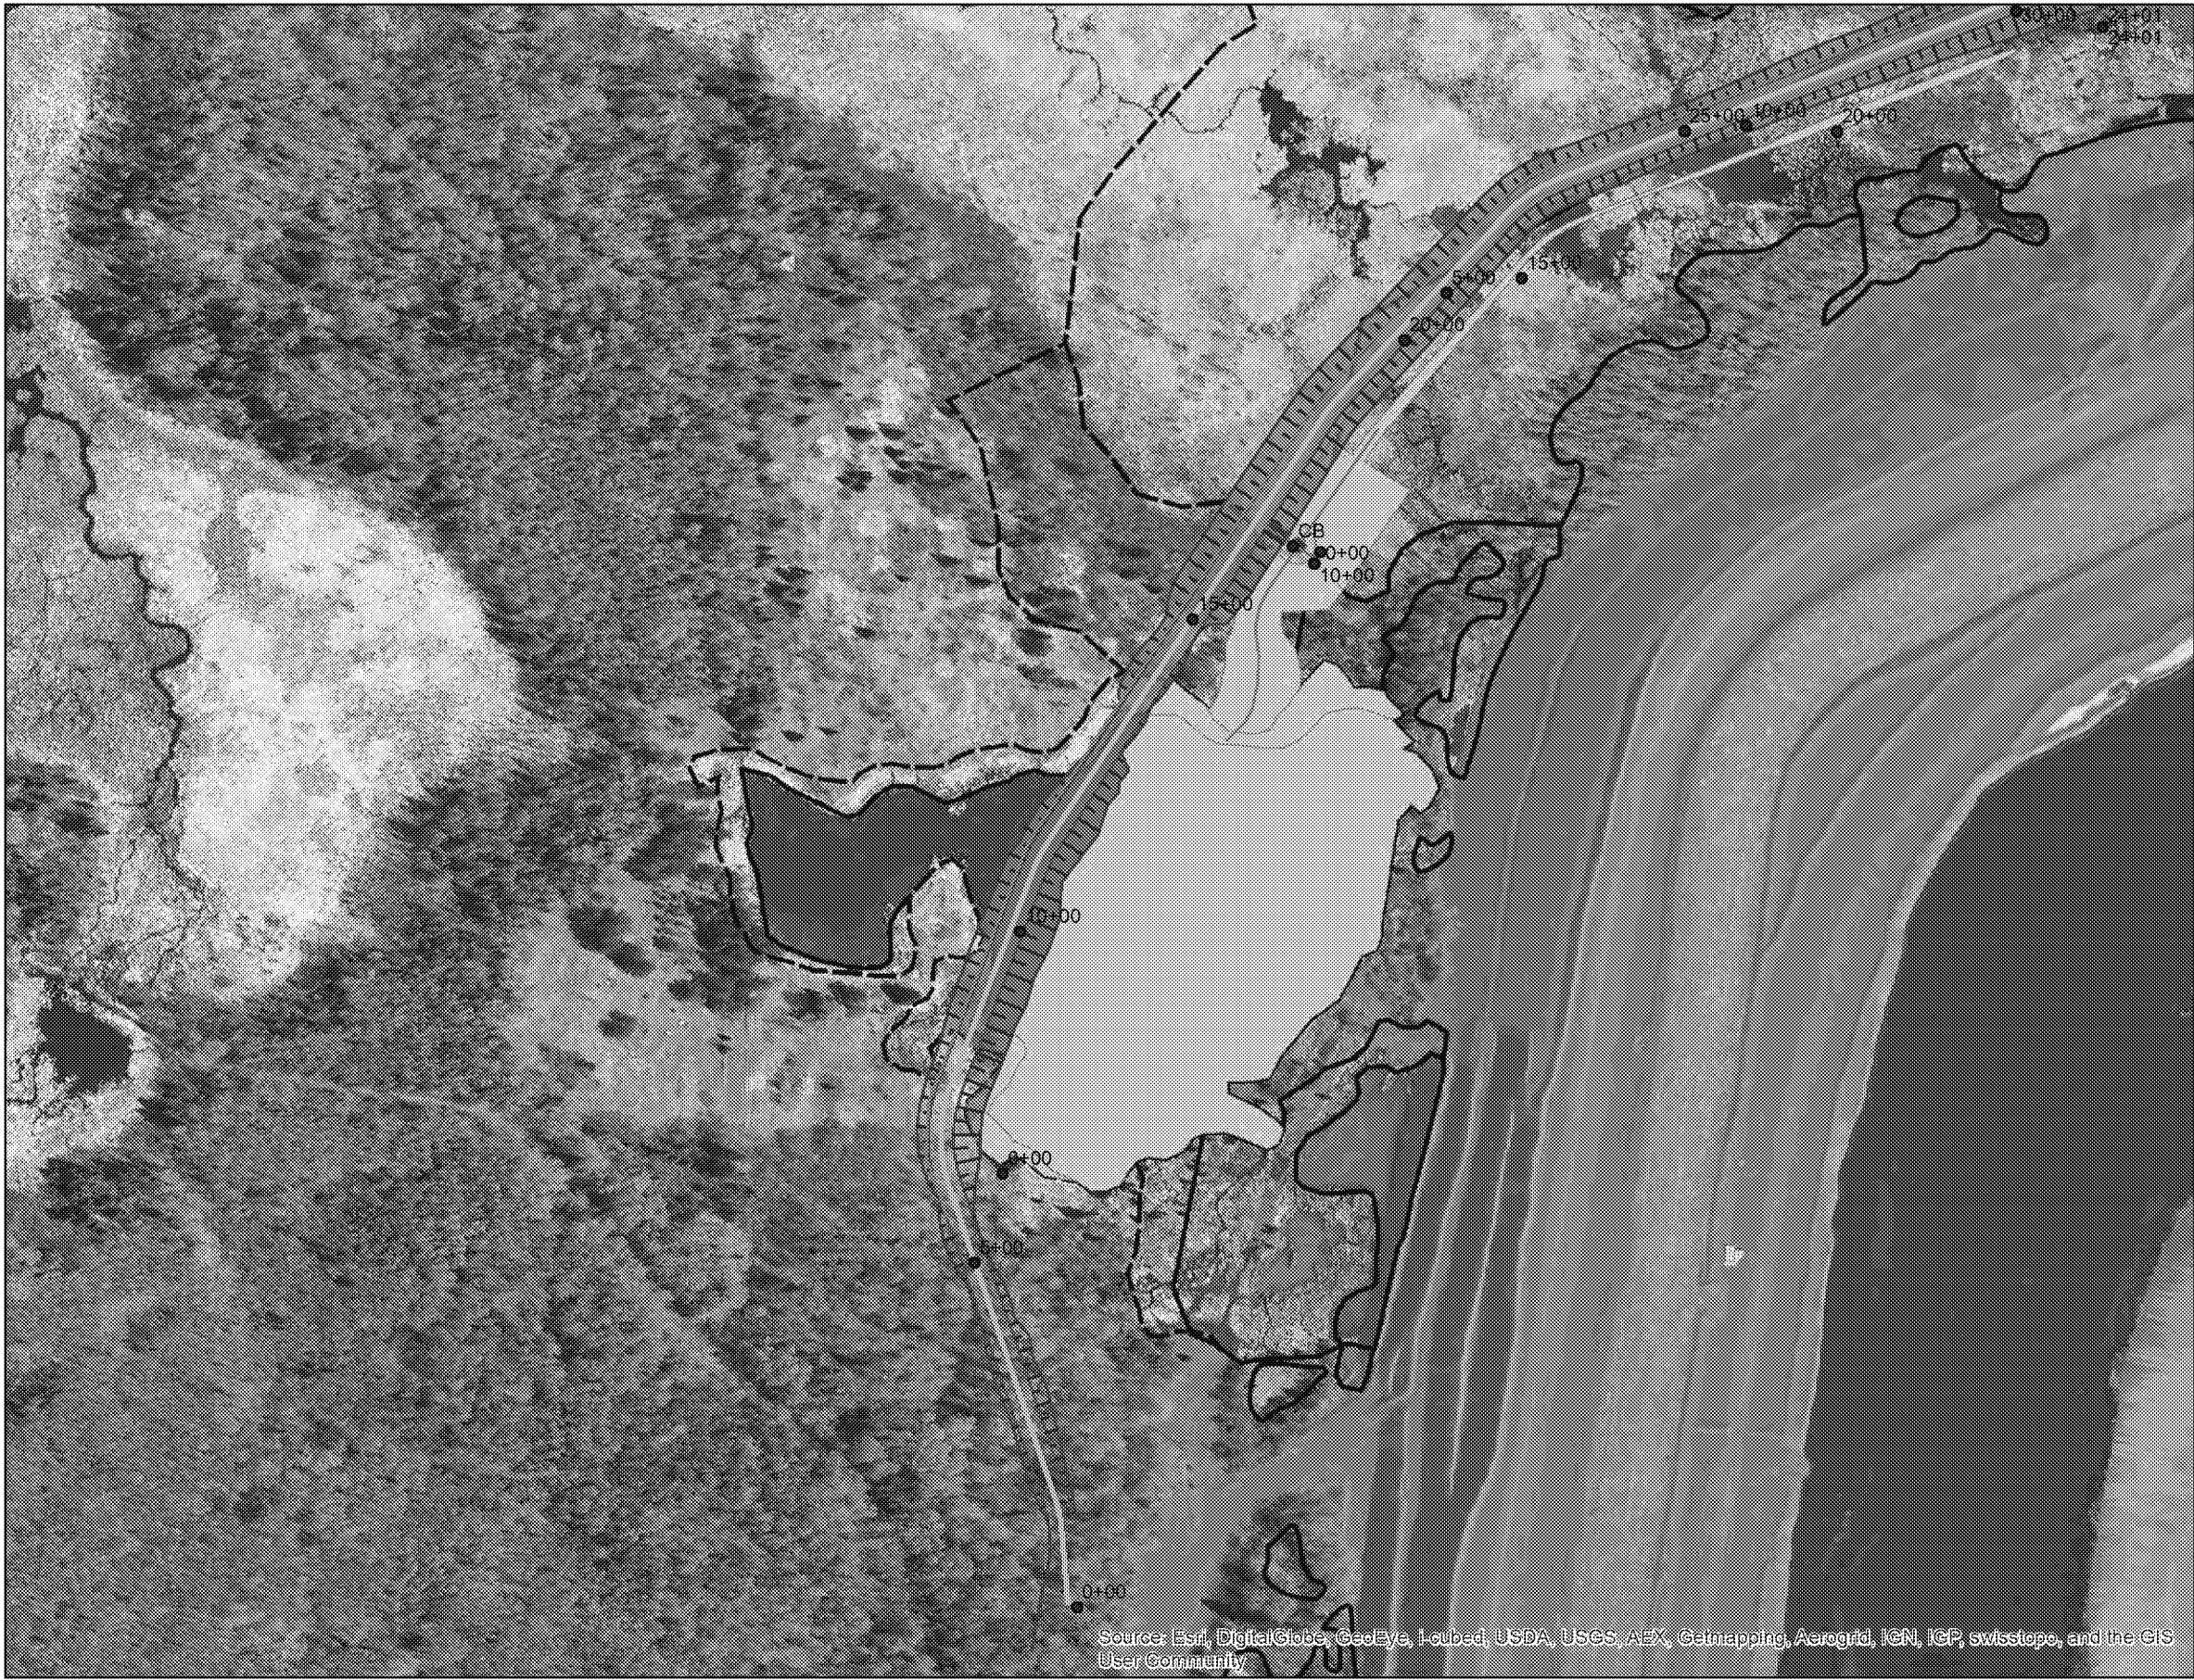
Figure 7
Wetland Impacts

- Road Centerline
- Pump Station
- Force Main
- Seep Collection Direct Impacts**
 - Pump Station
 - Road
- Seep Collection Hydrologic Impacts**
 - French Drain
- Wetland Boundary 2012
- Estimated Wetland Boundary 2014

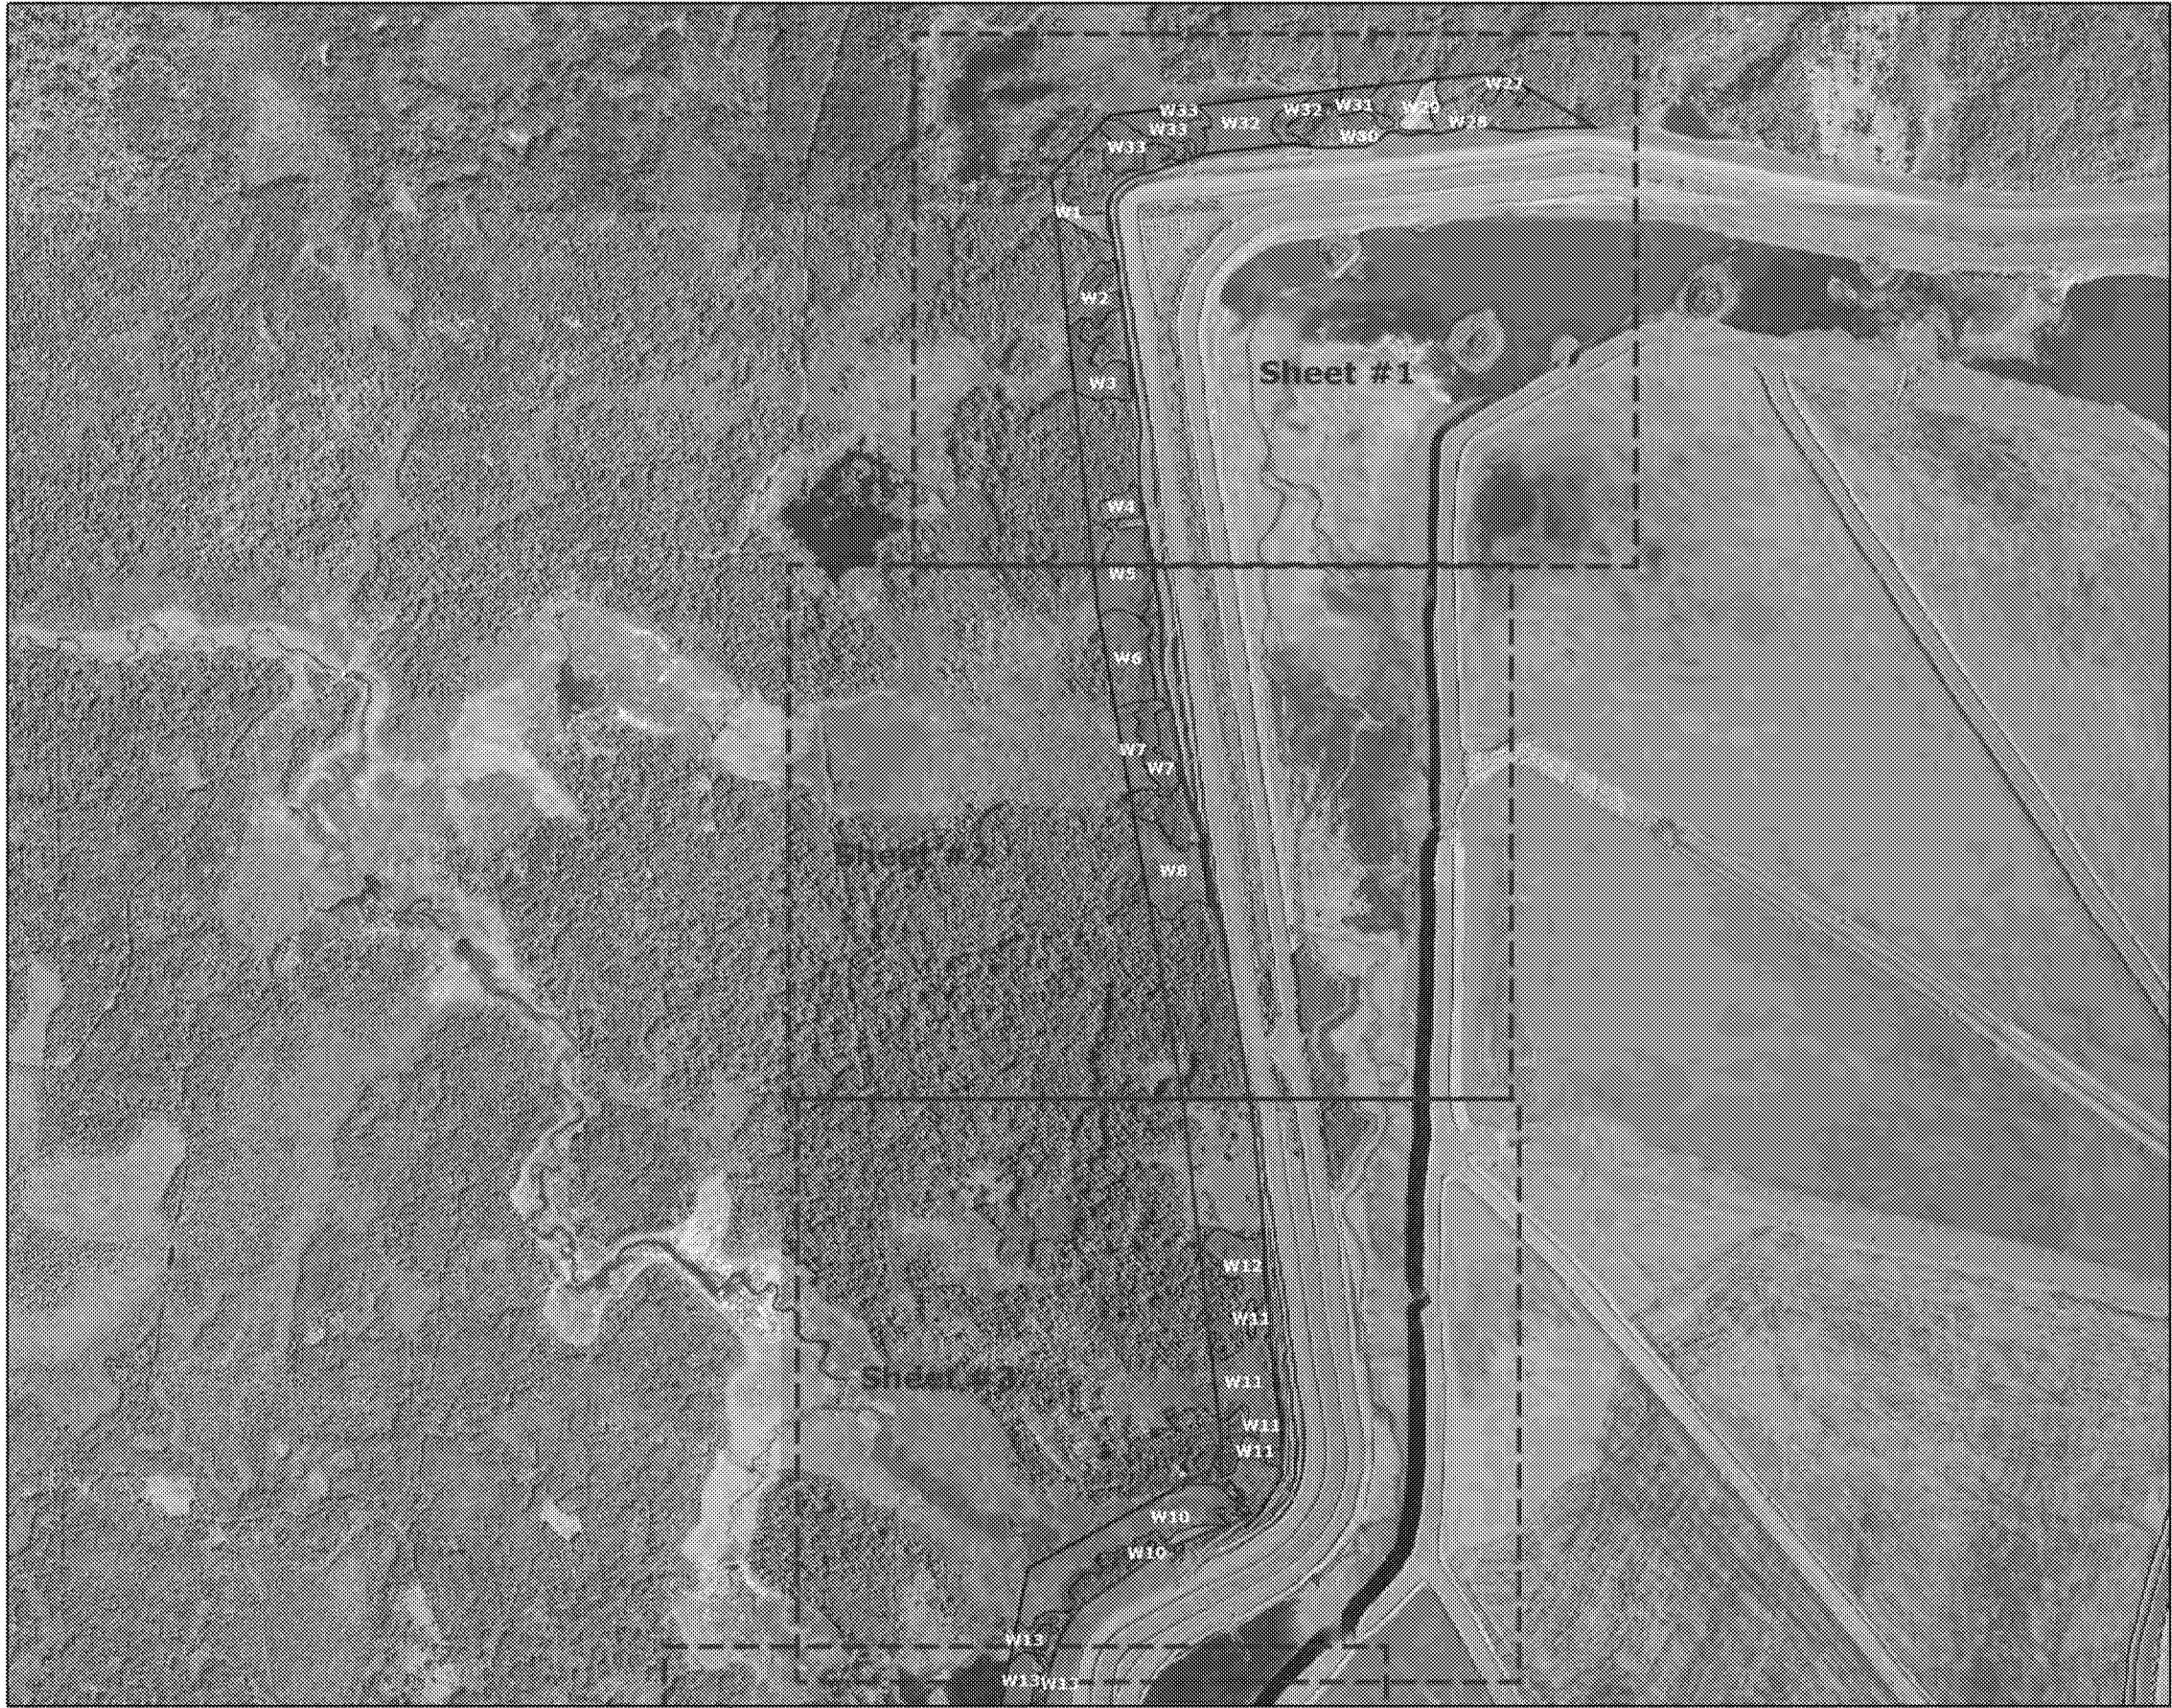
With the exception of localized areas where mining-related topographic alterations have occurred, topography within the project area is mostly level to gently rolling. Mining facility berms and dump areas adjacent to the project area are often very steep. Figure 2 shows the project area topography.

Prior to commencing field work, National Wetland Inventory and USGS topographic maps (Figure 2), the St. Louis County Soil Survey and aerial photography were reviewed for potential wetlands. These layers were reviewed in GIS to identify potential wetland areas. The entire project area was then systematically inspected for potential wetlands with sample points taken within all areas that were potentially wetland. Where wetlands were determined to exist, wetlands were assigned a unique number with “W” to denote wetland. If wetlands were not determined to exist at the sample point, the sample point was assigned the next number in the sequence following “NW” for non-wetland. Where wetlands were determined to exist, an upland sample point was established near the wetland-upland boundary. Wetland, upland and non-wetland sample point data sheets are in Appendix B.

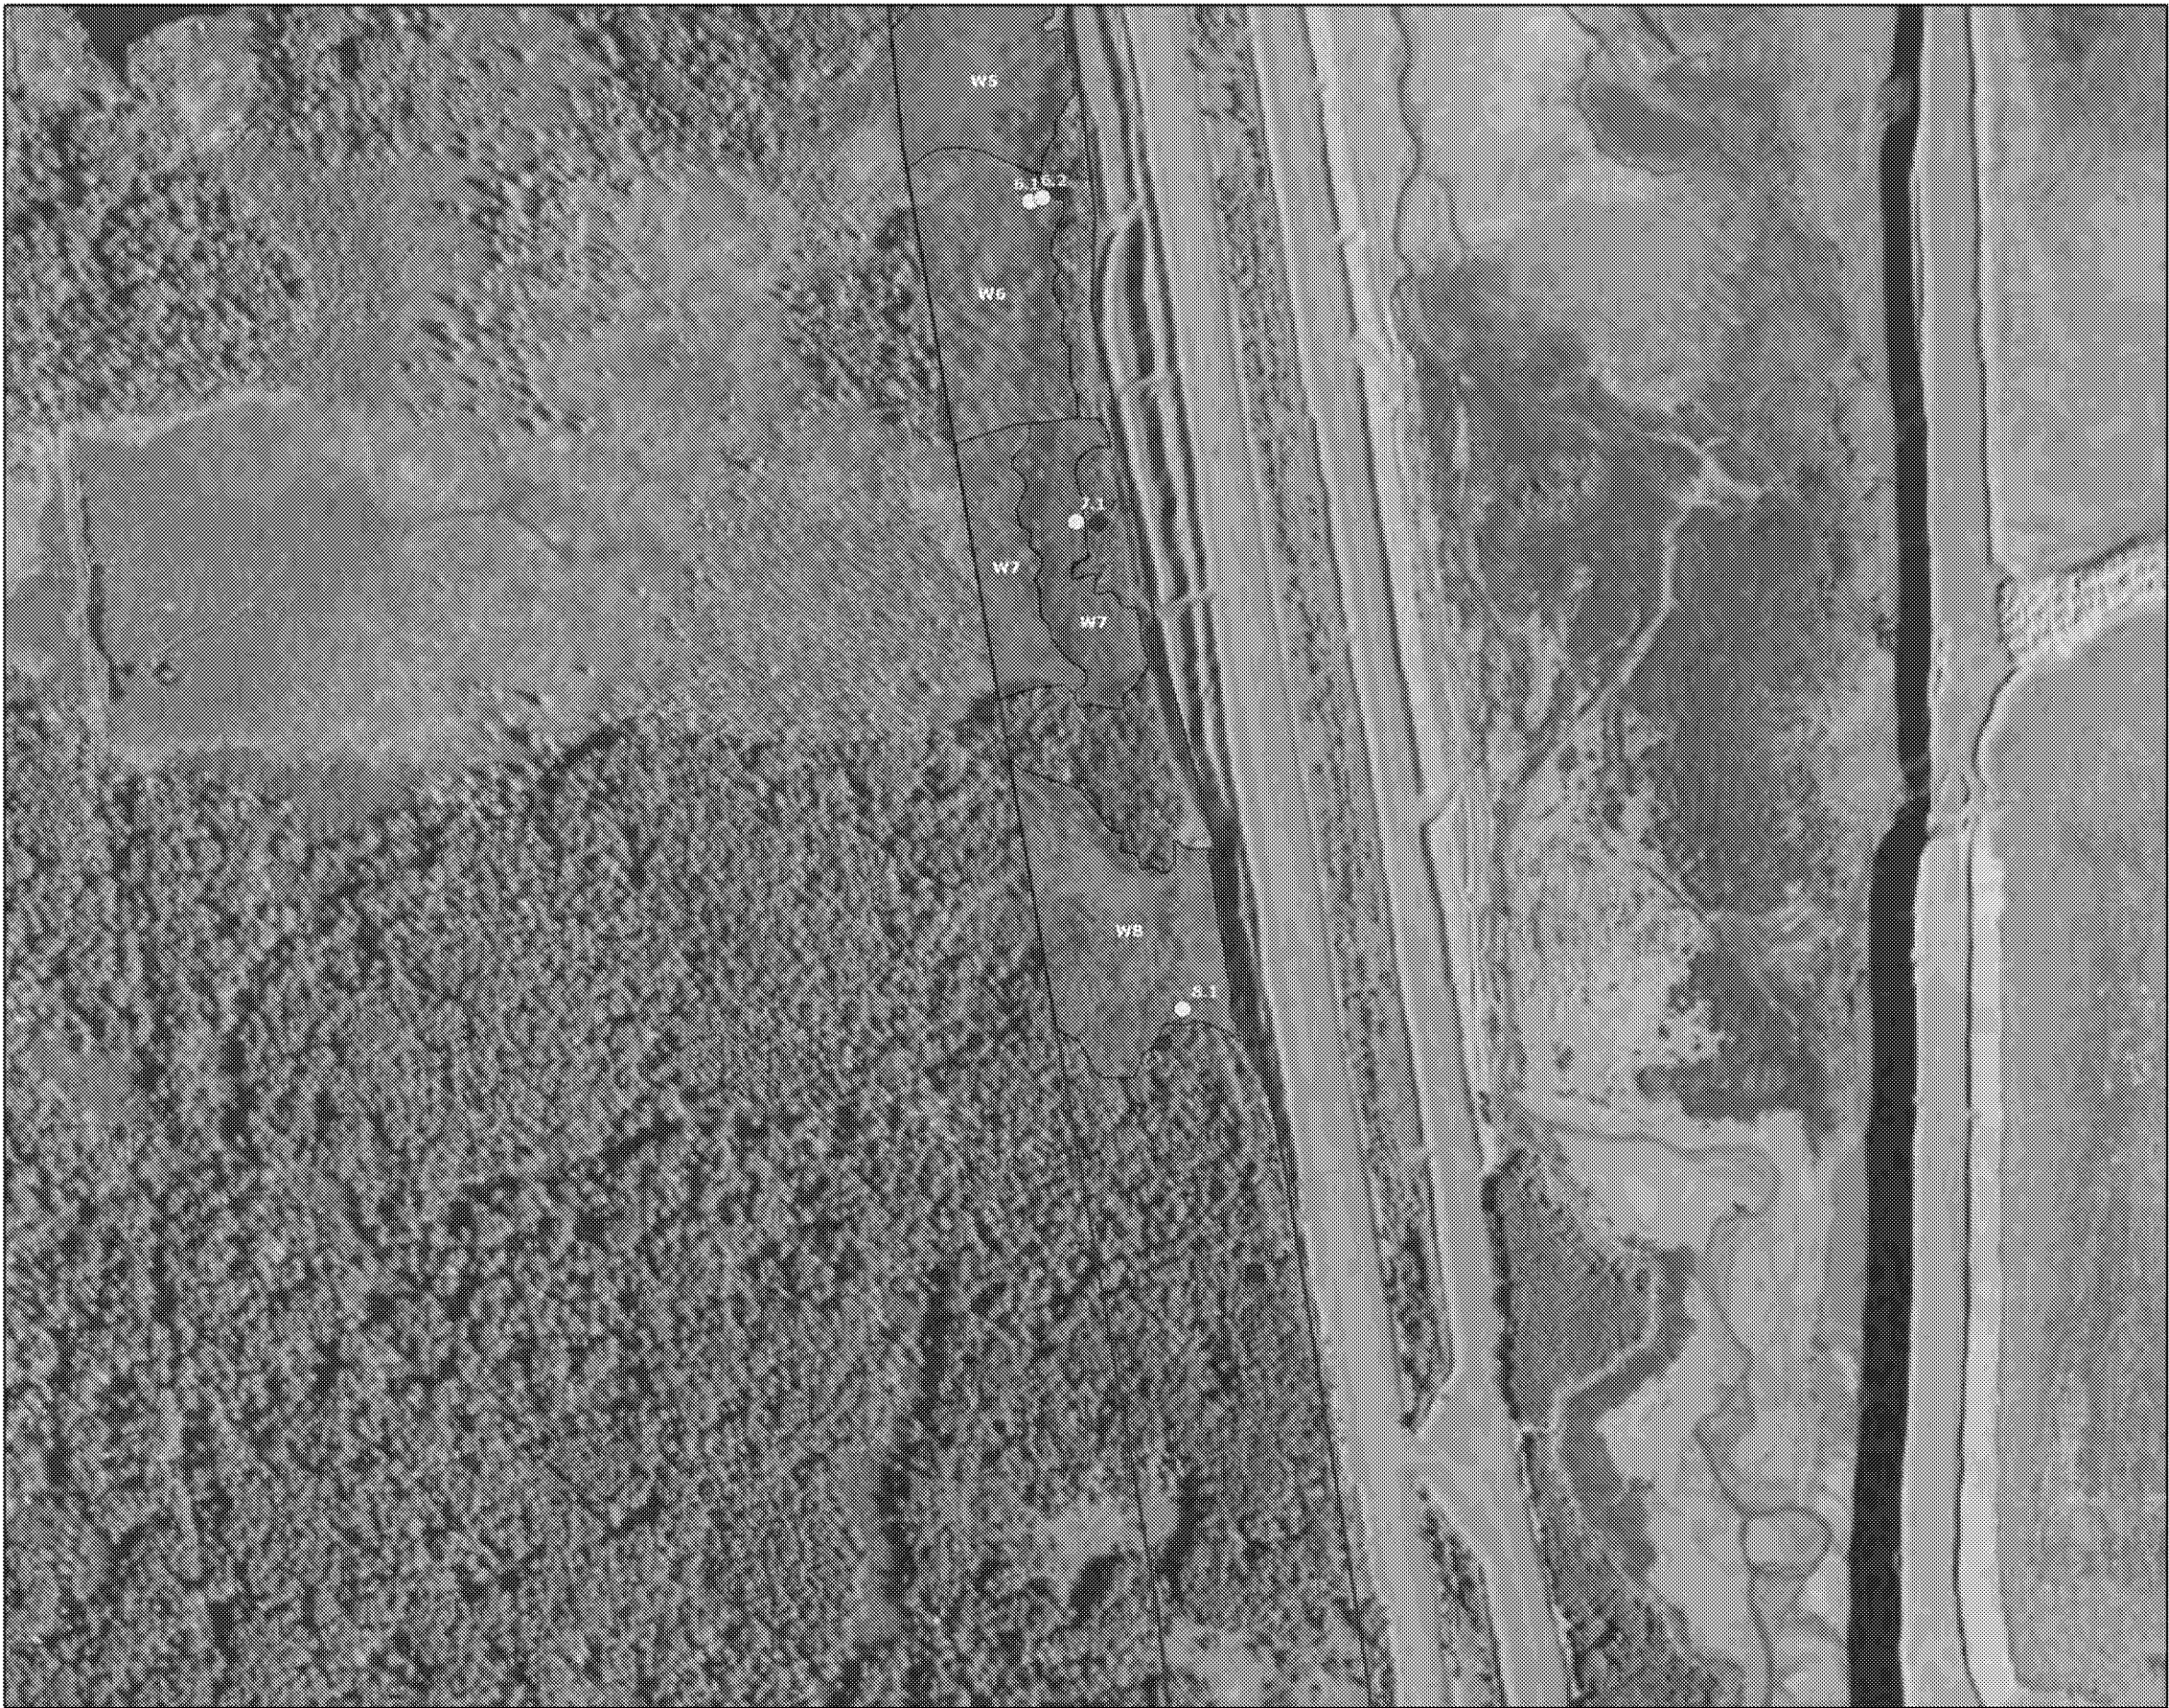
Figure 4A
Wetland Boundary Map
Sheet# 1

97.8 acres of Type 2, 3, 4, 5, 6 and 7 wetlands were identified within 32 wetland areas. The location of these wetlands and a breakdown of acres by wetland type are shown in Table 1. Wetland boundaries and sample point locations are shown in Appendix A, Figures 4A-4F. Data sheets for the 2011 wetlands (W1-W26) are shown in Appendix B of the 2011 Delineation Report. Data sheets for the wetlands delineated within the expanded project area (W27-W33) are shown in Appendix B of this report.
